Home Inspection Report

Sample Address
Columbus, OH 43000

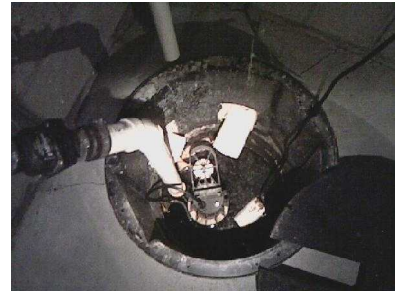
1. Main Basement Sump Pump: Submerged : - Inoperative at time of inspection, needs replaced.

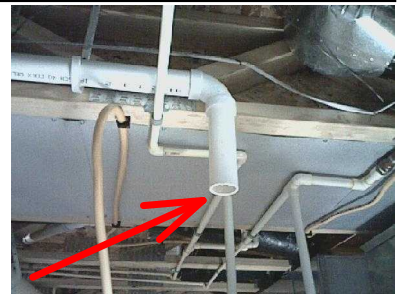
2. Drain Pipes: PVC : - An unfinished drain needs completed. This serves the second floor washer drain pan.

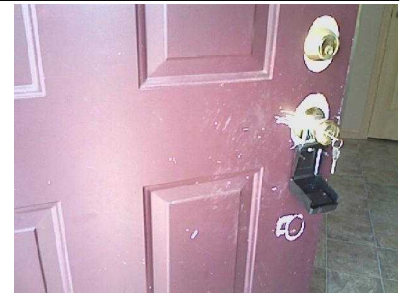
1. Entry Doors: Metal : - The front door needs to be repainted.

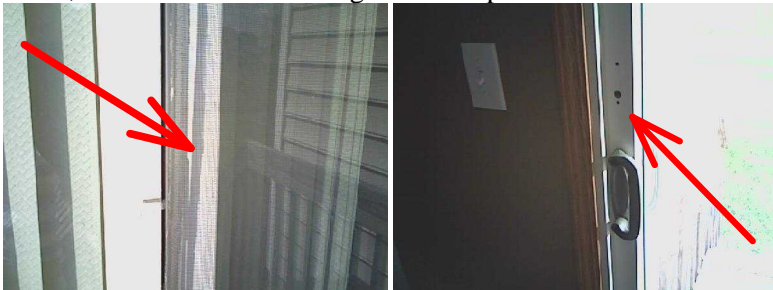
2. Patio Door: Vinyl sliding : - Screen door needs repair - torn screen.

Also, the door lock is missing - needs replaced.

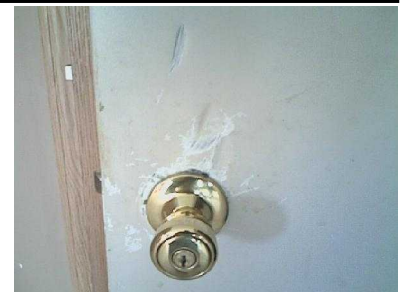
3. Attached Garage Service Doors: Metal : - The garage service door needs repaired.

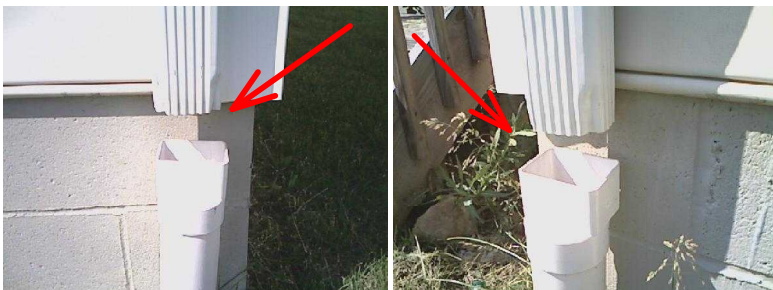
4. Downspouts: Aluminum : - The two rear downspouts are disconnected from their drains and should be fully re-connected.

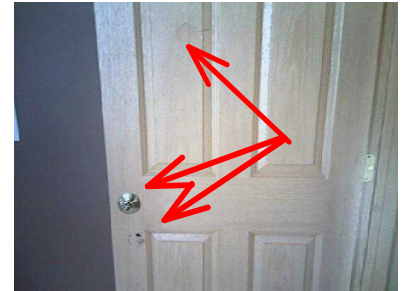
5. Master Bedroom Doors: Hollow wood : - The front door is damaged and missing a handle.

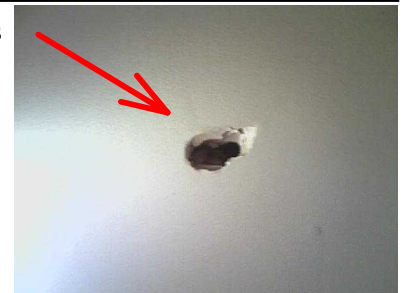
6. Front entry Living Space Walls: Painted drywall : - A hole in the stairwell wall needs repair.

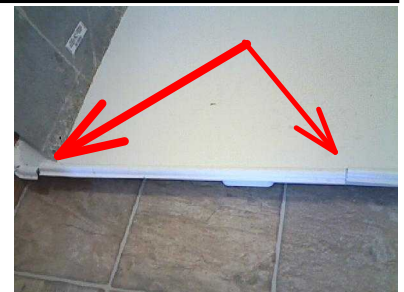
7. 2nd Floor Laundry Room/Area Washer Drain: Drain pan : - The plastic drain pan is cracked and should be replaced.

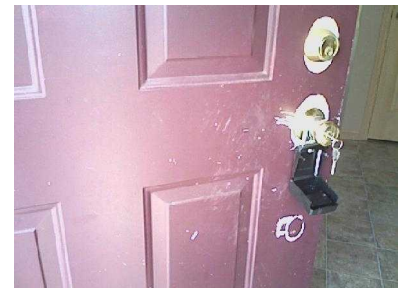
- Acceptable Type: Brick
- All four sides Exterior Surface
- Acceptable Type: Vinyl siding
- Acceptable Trim: Vinyl
- Acceptable Fascia: Vinyl
- Acceptable Soffits: Aluminum
- Acceptable Door Bell: Hard wired
- Minor Concern Entry Doors: Metal : - The front door needs to be repainted.

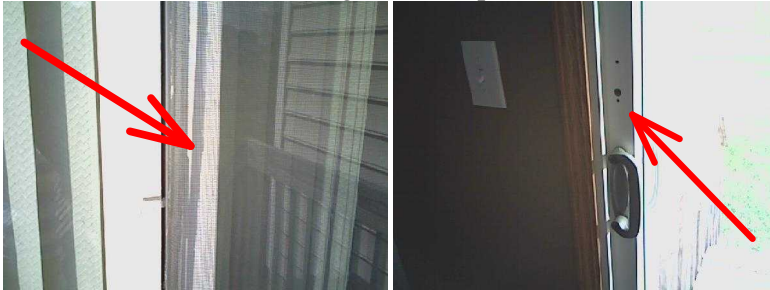
Minor Concern Patio Door: Vinyl sliding : - Screen door needs repair - torn screen.

Also, the door lock is missing - needs replaced.

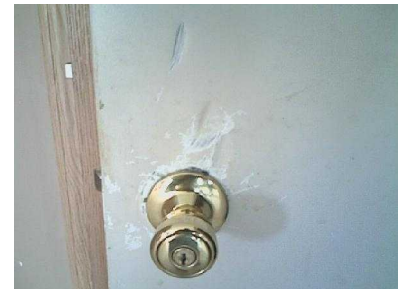
- Type of Structure: Attached Car Spaces: 2
- Acceptable Garage Doors: Aluminum
- Acceptable Door Operation: Manual
- Minor Concern Service Doors: Metal : - The garage service door needs repainted.

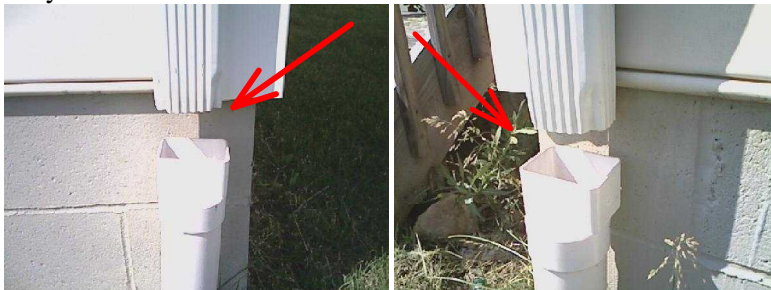
- Acceptable Unable to Inspect: 0%
- Acceptable Material: Dimensional (architectural-grade) asphalt shingle
- Type: Gable
- Approximate Age: Original
- Acceptable Flashing: Aluminum
- Acceptable Valleys: Preformed metal
- Acceptable Plumbing Vents: PVC
- Acceptable Electrical Mast: Underground utilities
- Acceptable Gutters: Aluminum
- Minor Concern Downspouts: Aluminum : - The two rear downspouts are disconnected from their drains and should be fully re-connected.

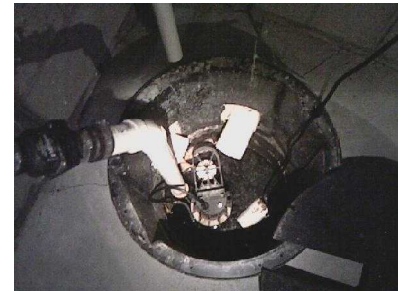
Acceptable	Unable to Inspect: 0%
Acceptable	Ceiling: Exposed framing
Acceptable	Walls: Exposed cinder block
Acceptable	Floor: Poured concrete slab
Acceptable	Floor Drain: Surface drain
Acceptable	Windows: Vinyl awning
Acceptable	Electrical: 110 VAC GFCI
Acceptable	Smoke Detector: Hard wired with battery back up
Acceptable	HVAC Source: Air exchange ventilation
Major Concern	Sump Pump: Submerged : - Inoperative at time of inspection, needs replaced.

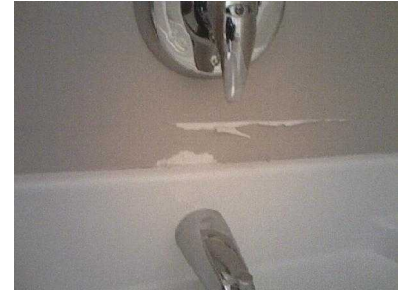
Acceptable Ceiling: Painted drywall
Acceptable Walls: Painted drywall : - Some paint touch-up is needed above the bathtub spout.

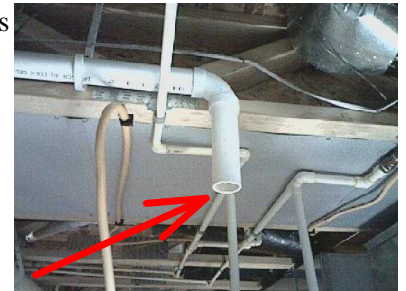
- Acceptable Service Line: ABS
- Acceptable Main Water Shutoff: Basement
- Acceptable Water Lines: PVC
- Major Concern Drain Pipes: PVC : - An unfinished drain needs completed. This serves the second floor washer drain pan.

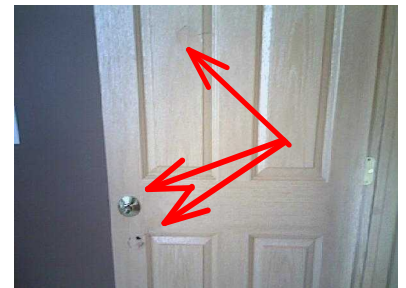
- Acceptable Closet: Walk-in
- Acceptable Ceiling: Painted drywall
- Acceptable Walls: Painted drywall
- Acceptable Floor: Carpet
- Minor Concern Doors: Hollow wood : - The front door is damaged and missing a handle.

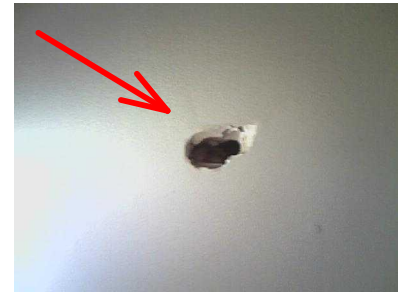
- Acceptable Closet: Single
- Acceptable Ceiling: Painted drywall
- Minor Concern Walls: Painted drywall : - A hole in the stairwell wall needs repair.

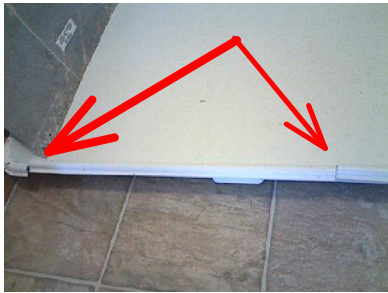
- 2nd Floor Laundry Room/Area
- Acceptable Ceiling: Painted drywall
 - Acceptable Walls: Painted drywall
 - Acceptable Floor: Vinyl floor covering
 - Acceptable Doors: Hollow wood
 - Acceptable Electrical: 110 VAC
 - Acceptable Washer Hose Bib: Ball valves
 - Acceptable Washer and Dryer Electrical: 110-240 VAC
 - Acceptable Dryer Vent: Metal flex
 - Minor Concern Washer Drain: Drain pan : - The plastic drain pan is cracked and should be replaced.
